Midway City Council
4 December 2018
Regular Meeting

LaBarge Subdivision /
Preliminary Approval

CITY COUNCIL MEETING STAFF REPORT

WETLANDS & WATERS DELINEATION
Delineation of Aquatic Resources
Corps File SPK-2017-00305-UO

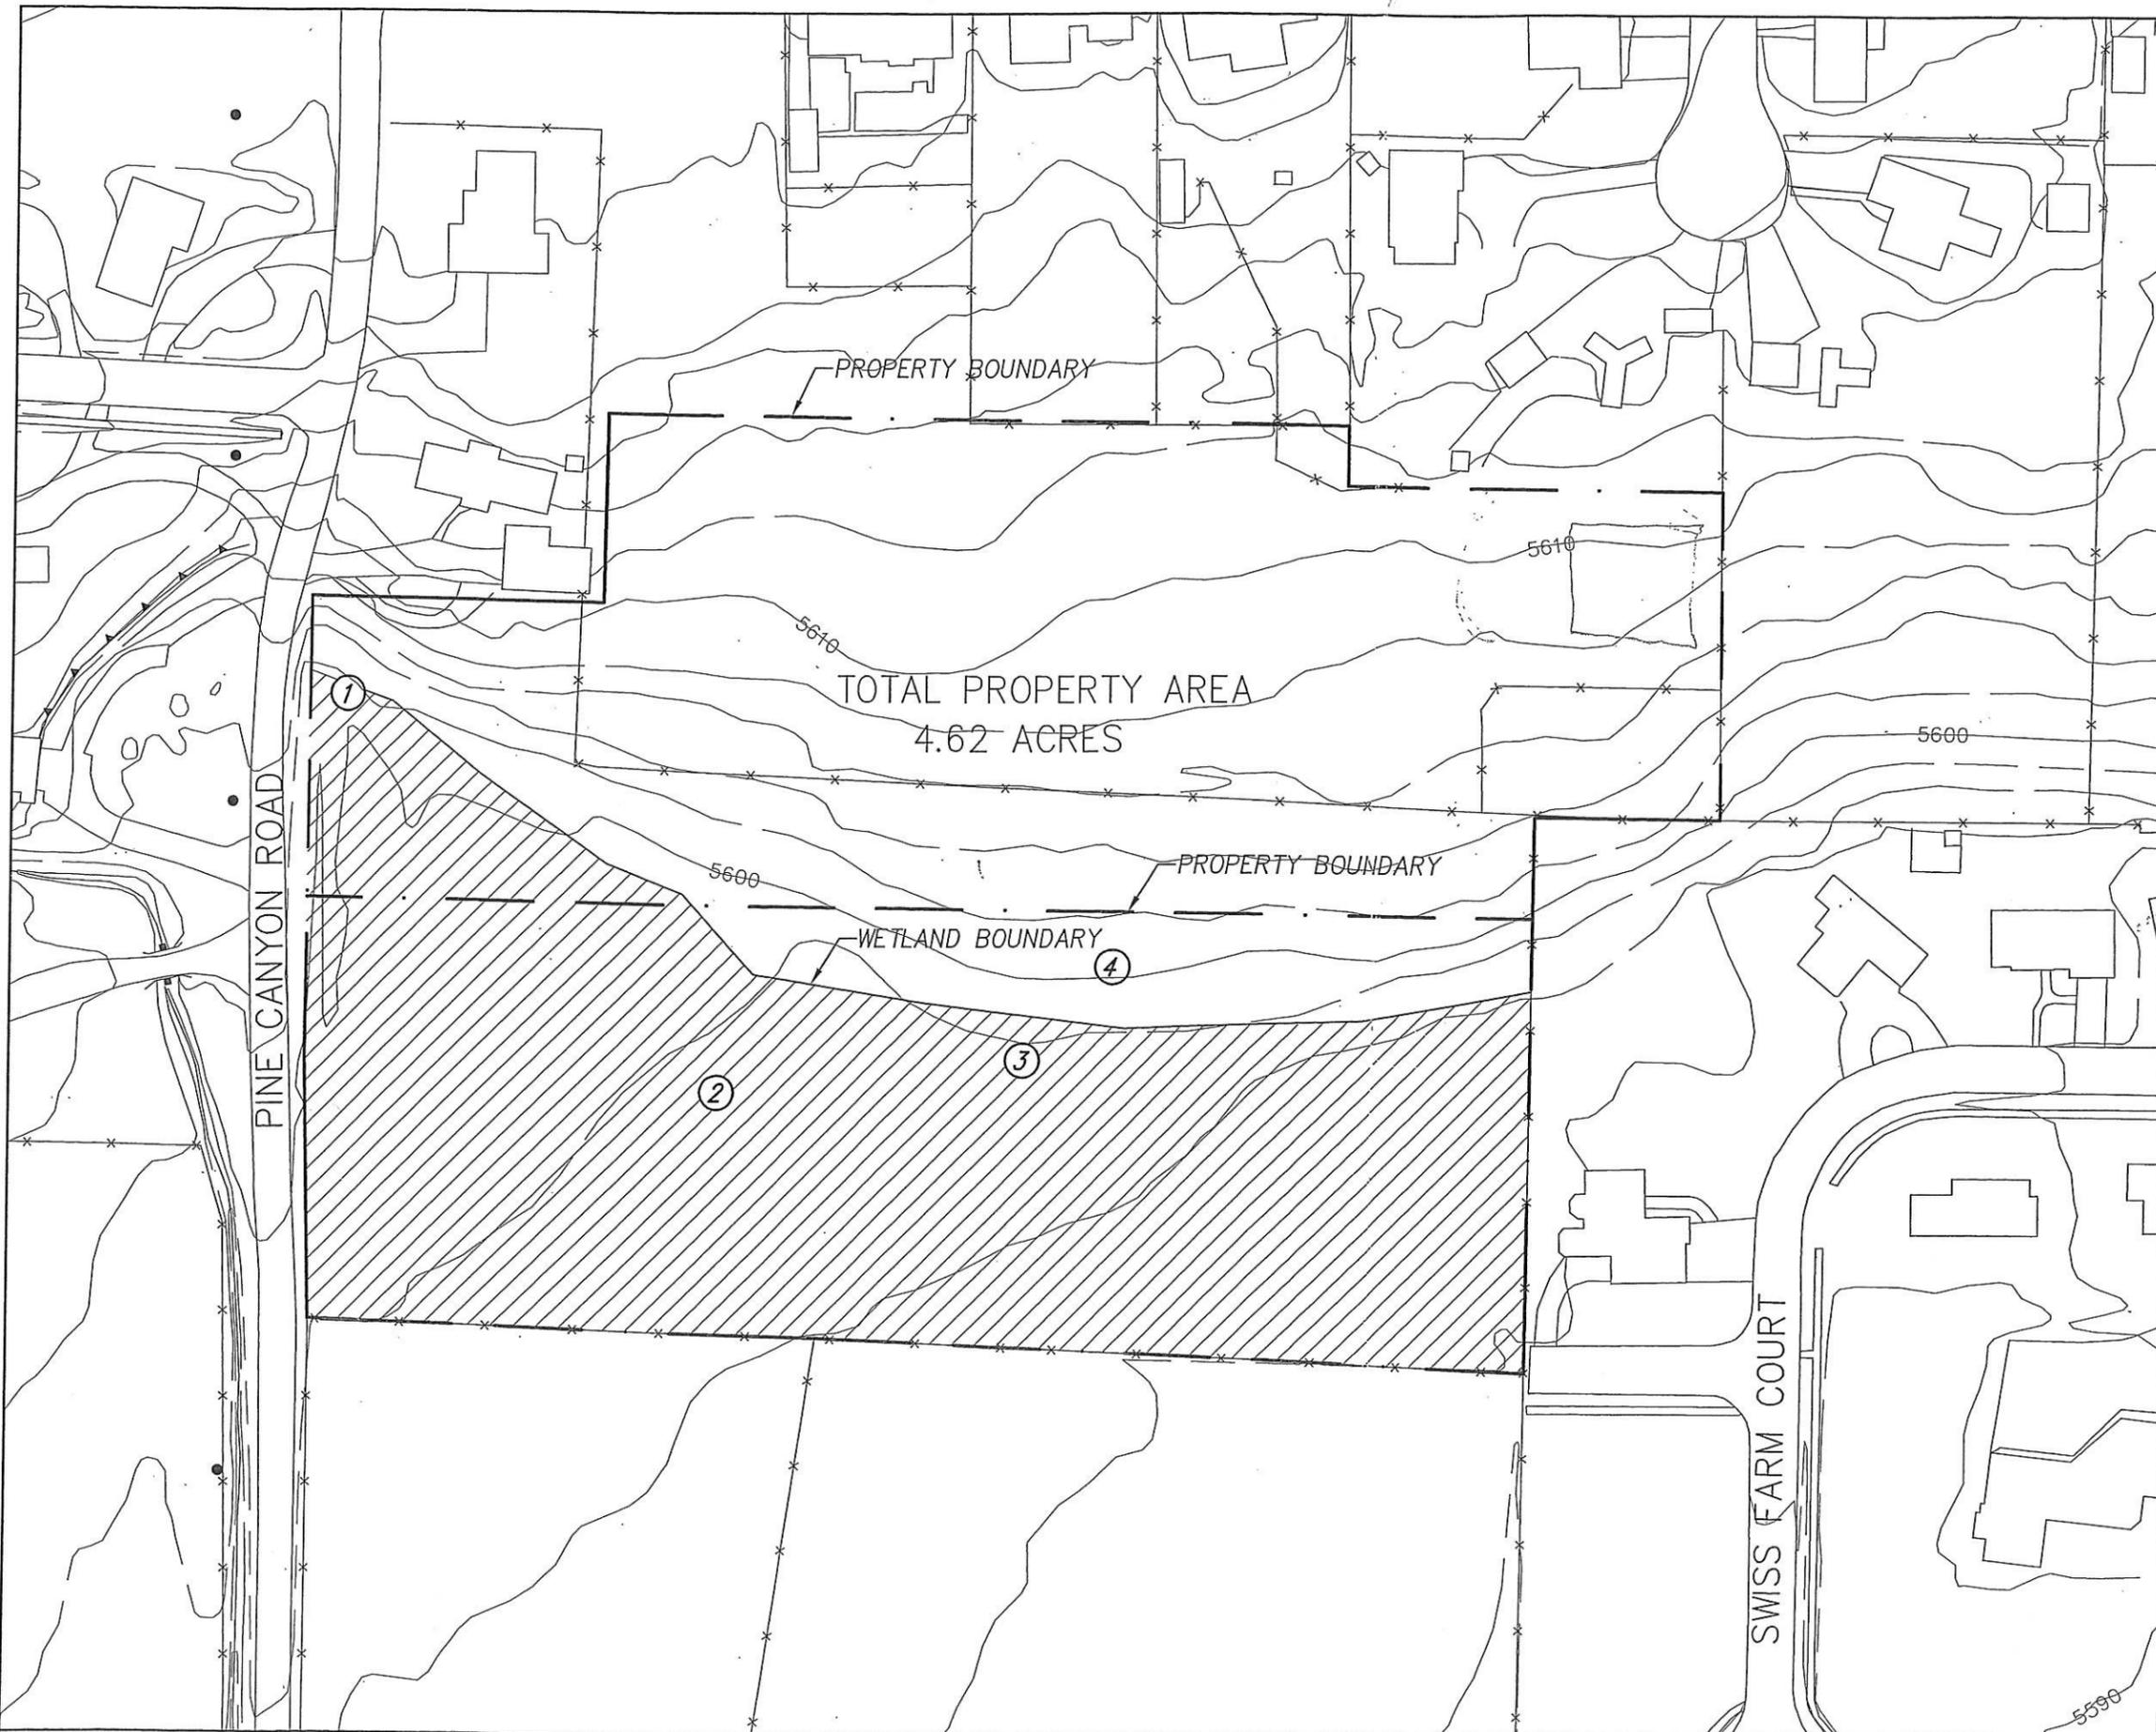
- ① DATA POINT
- WETLANDS (3.87 ACRES)

922 Pine Canyon Road
Midway, Utah

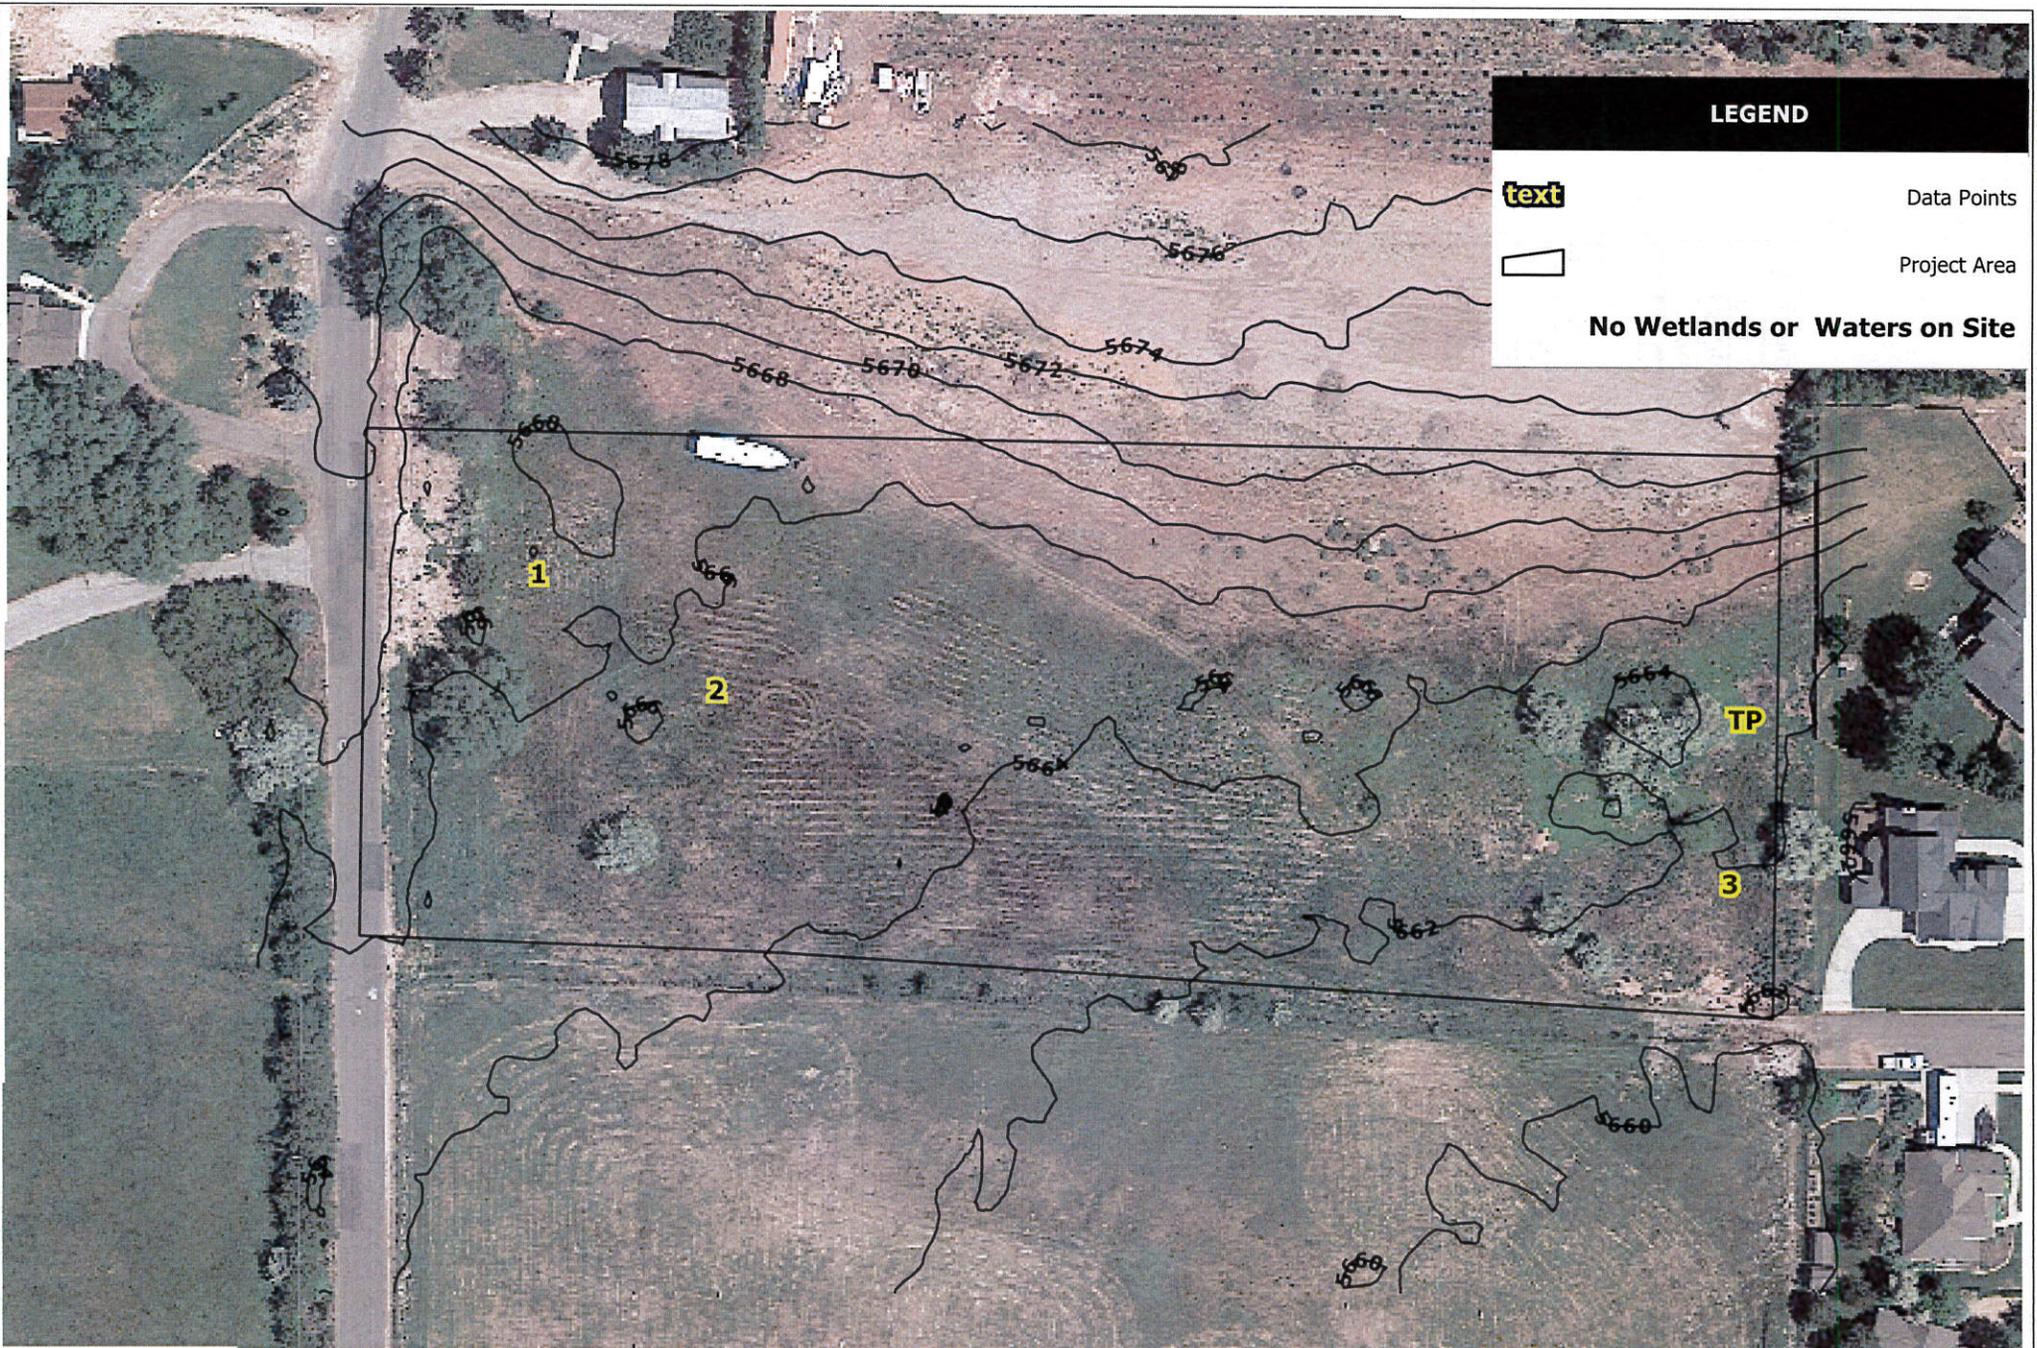
SHEET 2

No Wetlands or Waters on Site

WETLANDS AND WATERS
 LaBarge Property
 922 Pine Canyon Road
 Midway, Utah

Field work was conducted April 11-12, 2018. Data was collected from three locations and an existing test pit was also observed for depth to groundwater. Data points are shown on Sheet 2 in Appendix A. All other data are recorded on attached data forms in Appendix B. Boundaries of wetlands and/or waters were determined based on general observations as well as specific vegetation, soils and hydrology data from each sample location. In this case, there are no wetland on the site nor any water features.

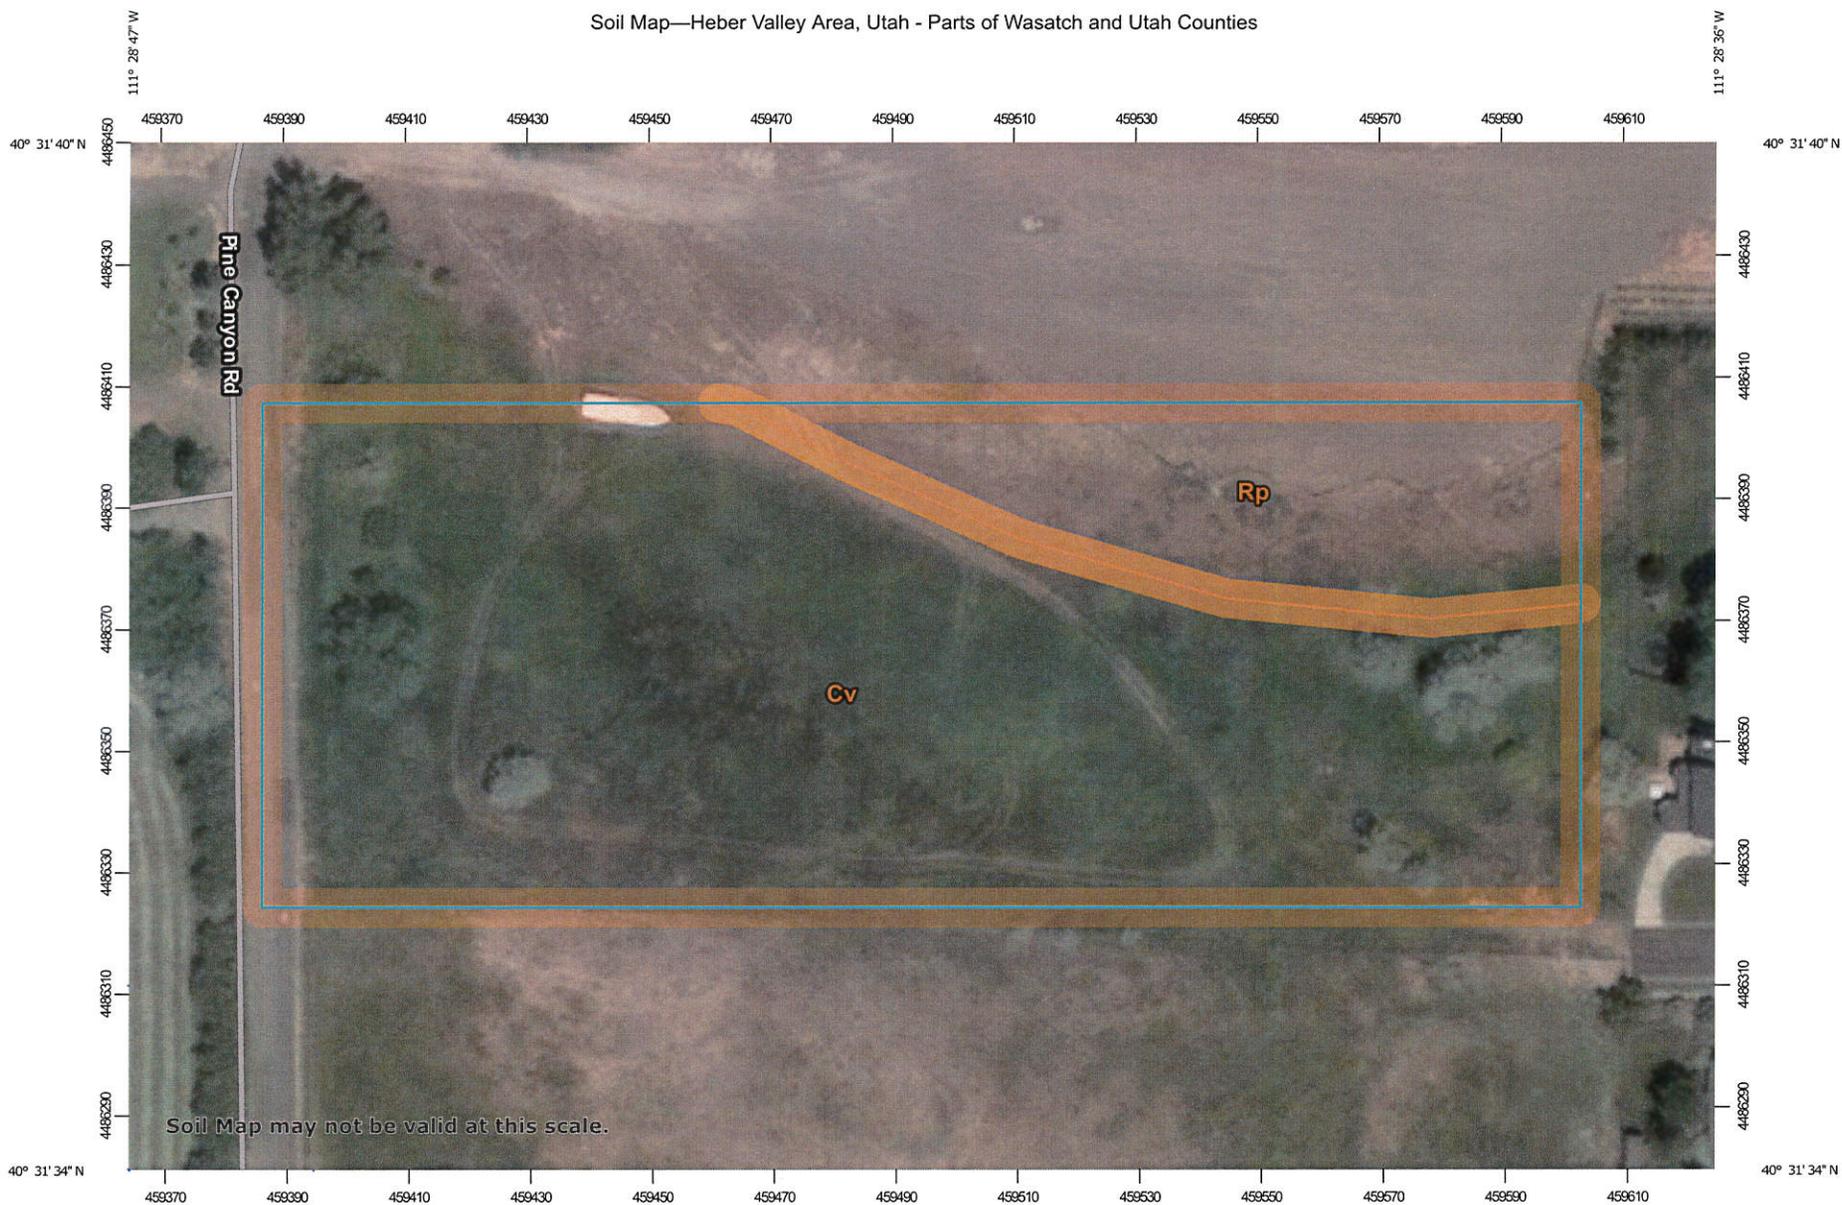
Soil Map—Heber Valley Area, Utah - Parts of Wasatch and Utah Counties

Map Unit Symbol	Map Unit Name	Acres in AOI	Percent of AOI
Cv	Cudahy silt loam, cold variant	3.6	80.8%
Rp	Rock land, travertine	0.9	19.2%
Totals for Area of Interest		4.5	100.0%

Soils colors are 5YR 2.5/1 generally to at least 6 inches over slightly lighter 7.5YR 3/1. In the area that has Juncus the 5YR 2.5/1 color extends to 20 inches and lacks hydric soil indicators. Texture ranges from sandy loam to sandy clay loam. The Natural Resources Conservation Service (NRCS) classifies lowland soil as Cudahy silt loam (Cv) and hillslope soil as Rock land, Travertine. The Cudahy soil is listed as a hydric soil series. The NRCS soil map is included in Appendix A.
